POTENTIAL FLOOD AND DEBRIS HAZARDS, AT WILLOW BEACH,
LAKE MEAD NATIONAL RECREATION AREA, ARIZONA

by Otto Moosburner and Patrick A. Glancy

Administrative Report for release only to
U.S. National Park Service
Prepared in cooperation with the U.S.
National Park Service

1978

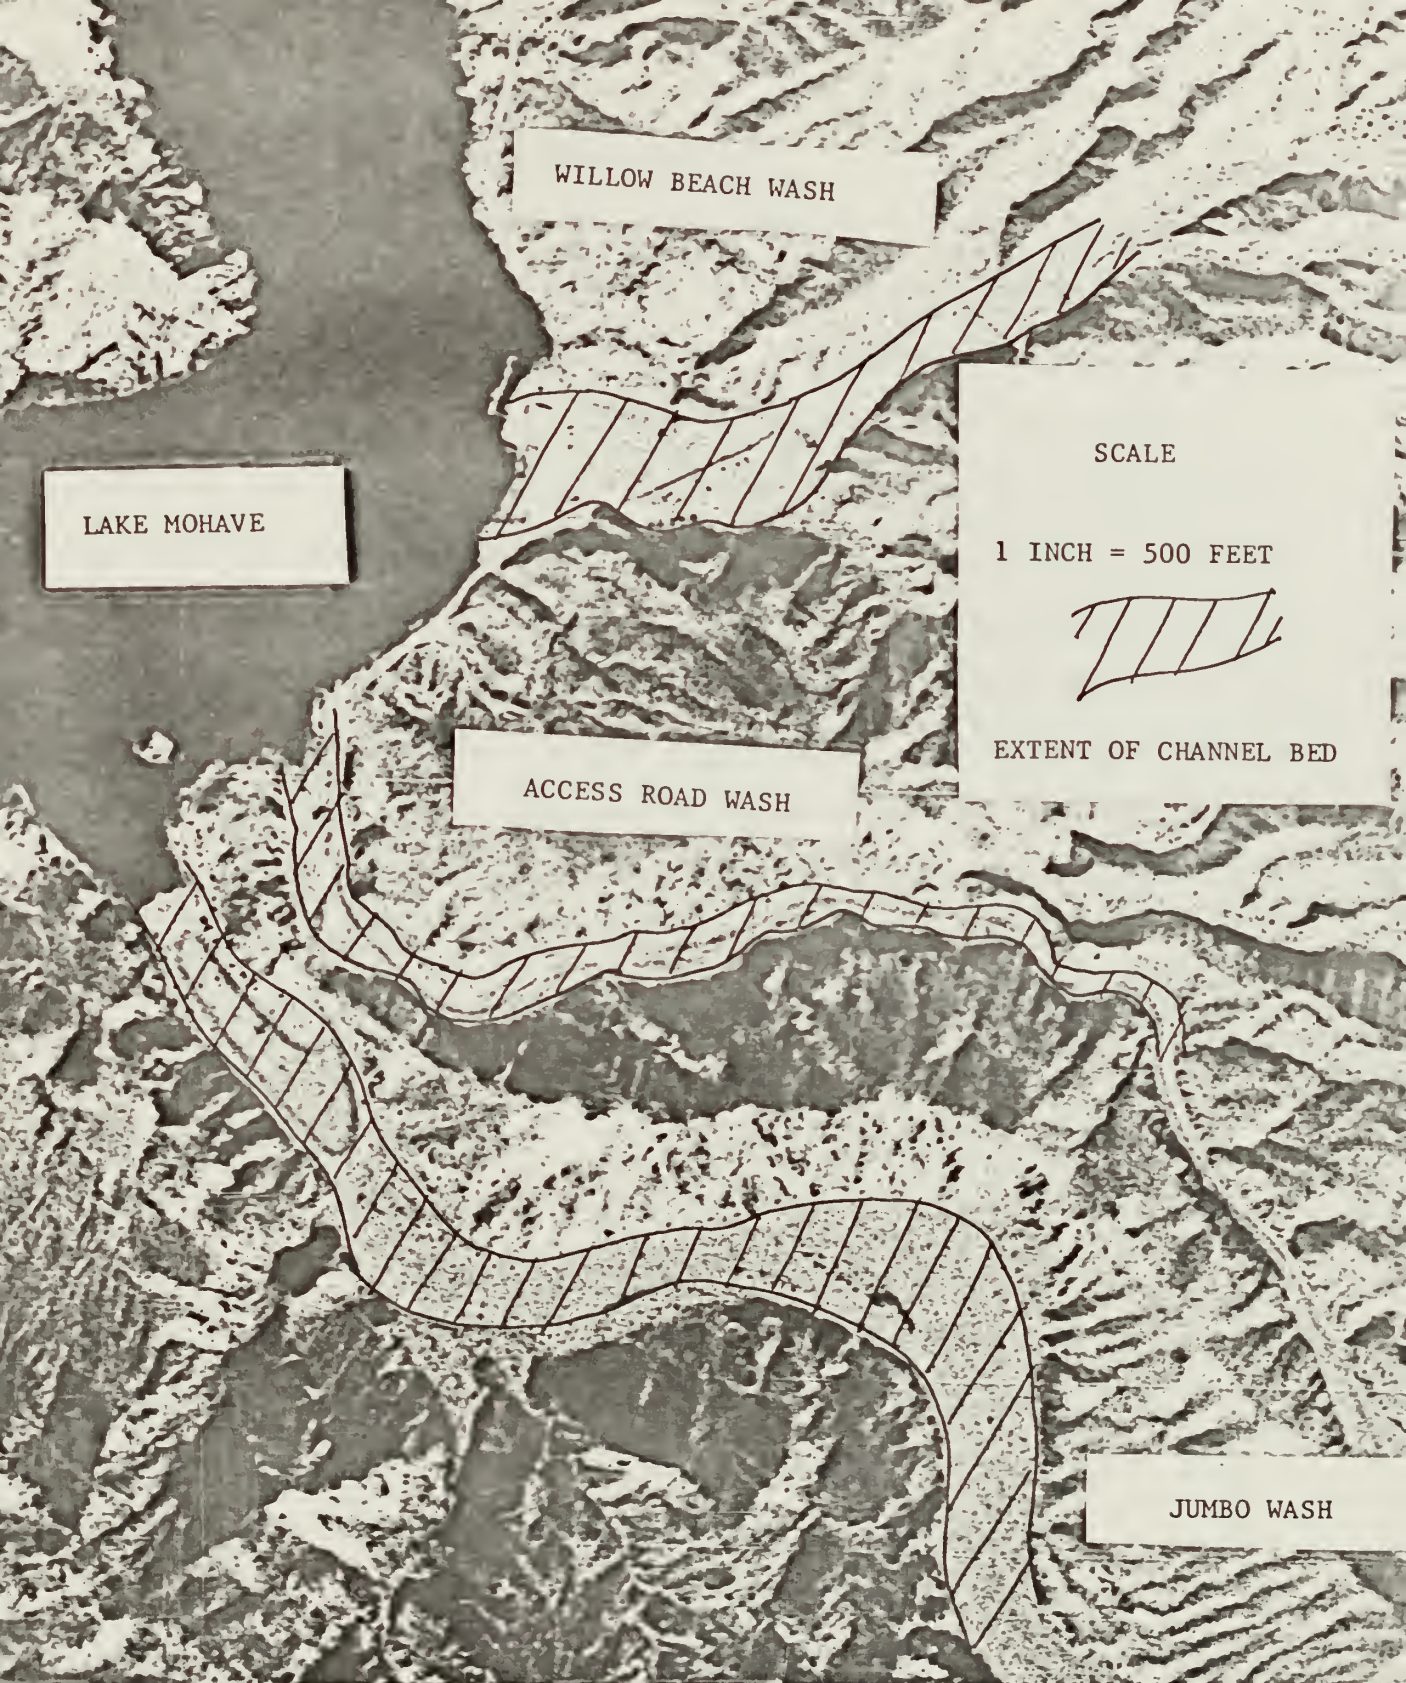
Figure 2.--A vertical view of Willow Beach and tributary washes,
February 22, 1954.

The above described recreation complex referred to in this study as Willow Beach includes the lower reaches of Willow Beach, Jumbo, and Access Road Washes as well as the lakefront between these washes (fig. 2). The names Willow Beach Wash and Access Road Wash were assigned for this report, as they both are unnamed on all maps. The study includes the appraisal of flood hazards in and along the channels of these three principal washes.

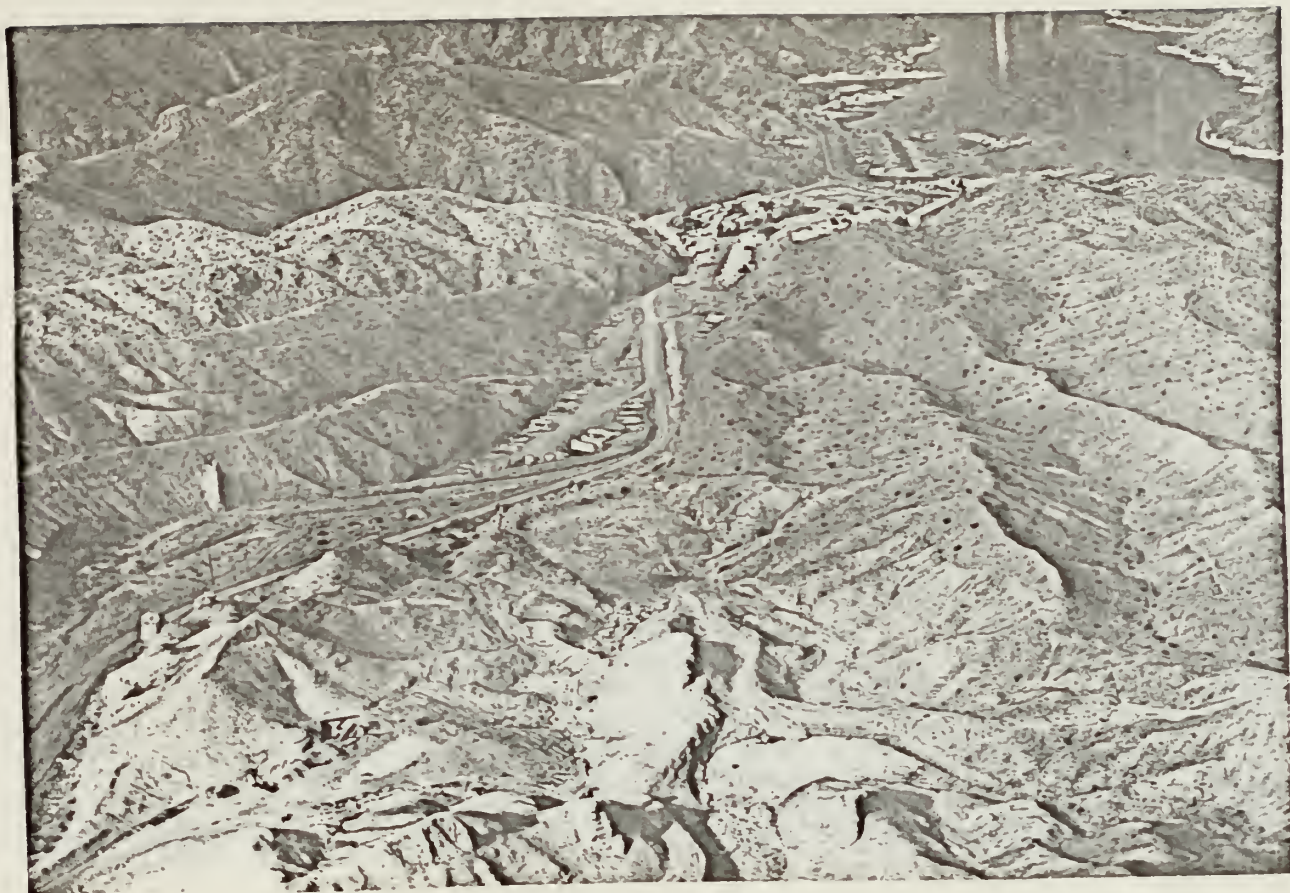
Figure 5.--A downstream oblique aerial view of manmade facilities in the terminal reach of Willow Beach Wash, August 3, 1977.

These homes are likely to be moved and severely damaged by the flows and will undoubtedly damage each other by impact during transit. The mobile homes are also subject to impact damage from smaller utility and boat trailers and boats that are now stored in and along the main channel just upstream from the mobile home residential area (fig. 5).

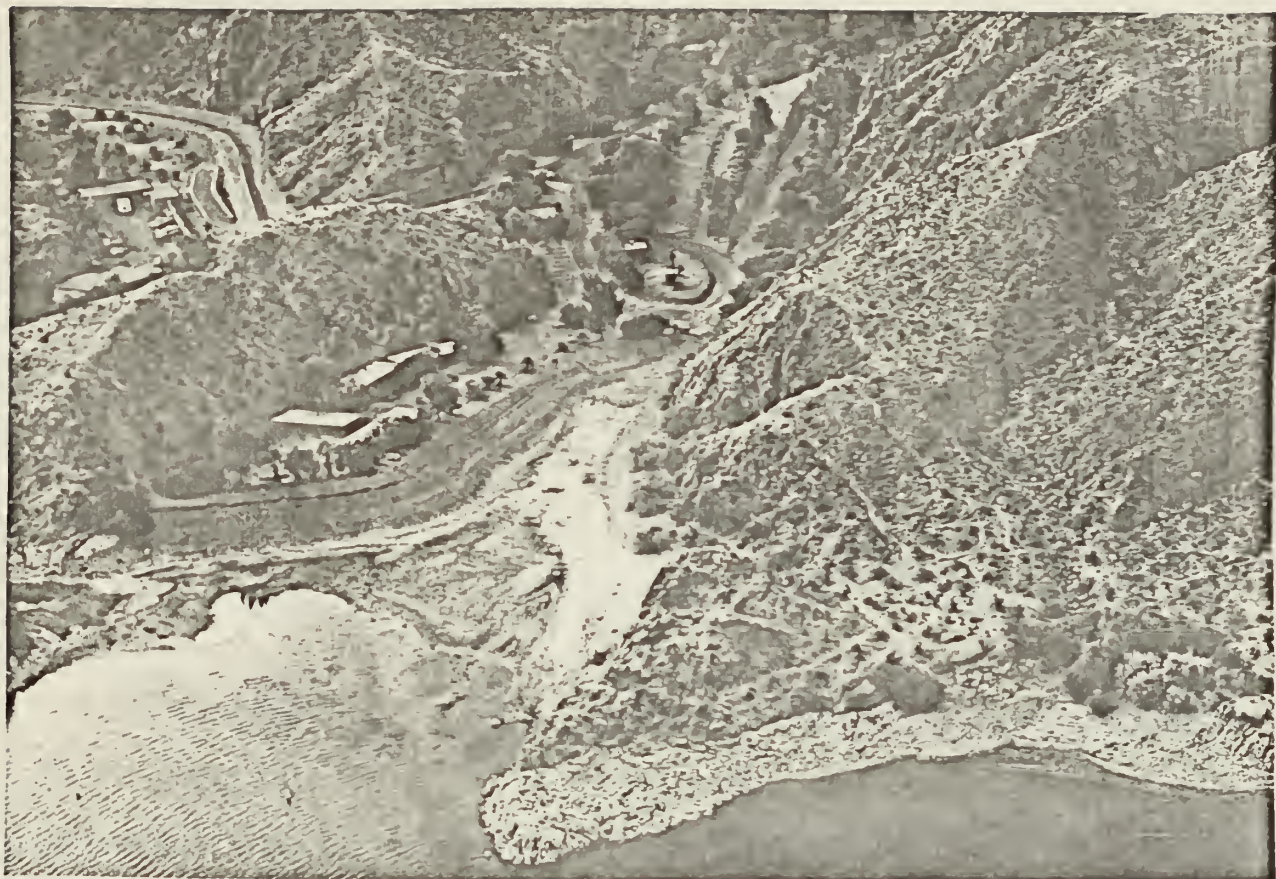
Figure 7.--An oblique aerial view of the sediment deposits at the terminus of Jumbo Wash, August 3, 1977

The permanent picnic facilities and any transient recreationists at the terminus of Jumbo Wash (fig. 7) are subject to impact hazards of moving debris and burial by debris from moderate to large-size floodflows. Sediment deposited recently by floodflows is evident in the sediment-clogged embayment exposed by low lake levels (fig. 7).

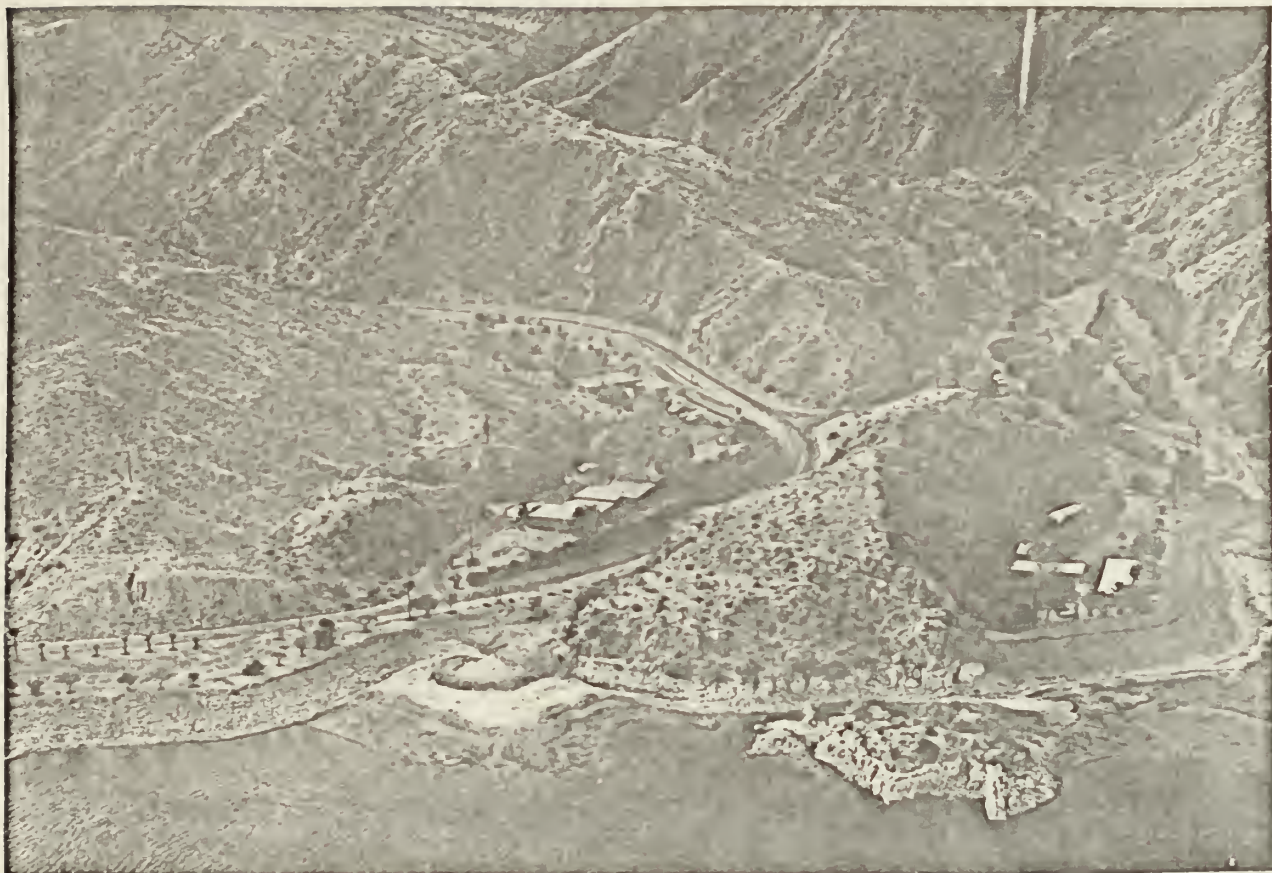
Figure 8.--An oblique aerial view of sediment deposits and manmade facilities at the terminus of Access Road Wash, August 3, 1977

The Park Ranger offices and residences are the only permanent buildings located in the path of extreme floods and their entrained debris loads (fig. 8). Damage to these buildings would probably not be too severe except in instances of very large floods. However, the potential hazard is large for storms of a severity comparable to that of the 1974 Eldorado Canyon flood. A storm of that size and intensity could create serious hazards to the dwellings and occupants from debris burial and impact.

Sediment deposition at the mouth of the wash is common and the present state of embayment filling at the terminus of Access Road Wash is shown in figure 8.
